## **Chapter 22 – INSPECTION OF HELICOPTER ROTOR BLADES BY NEUTRON- AND X-RAY RADIOGRAPHY**

**M. Balaskó and L. Horváth**  
MTA KFKI Atomic Energy Research Institute  
Budapest  
HUNGARY

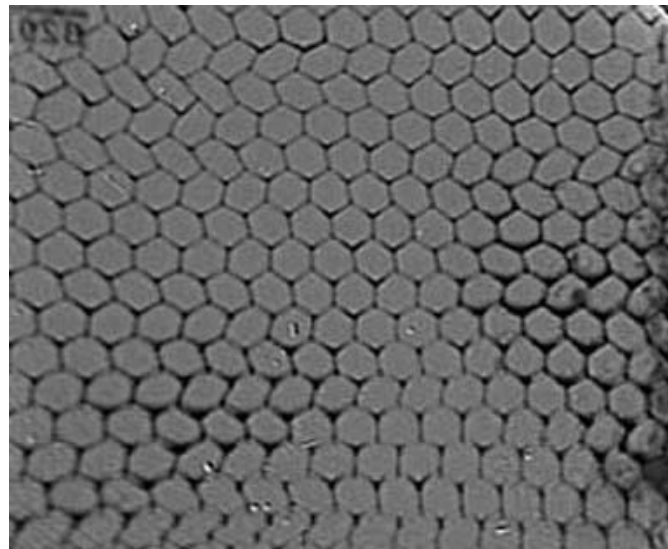
An important requirement of the radiography inspection was to visualize the resin-rich or resin-starved areas (defect types 4 and 5 in Table 22-1). These types of defects can be identified by the fact that they are clearly visible in the NR images due to the high neutron attenuation coefficient of hydrogen containing materials, while for X-ray radiography they are not visible. This is illustrated in Figure 22-9 which shows a resin-rich area in the honeycomb structure detected by NR. Another interesting point of this image is the well-resolved double contour lines, as they reflect the tilted position of the honeycomb elements.

**Figure 22-9: Dry NR Image of the Honeycomb Structure with Resin-Rich Areas (dark spots).**

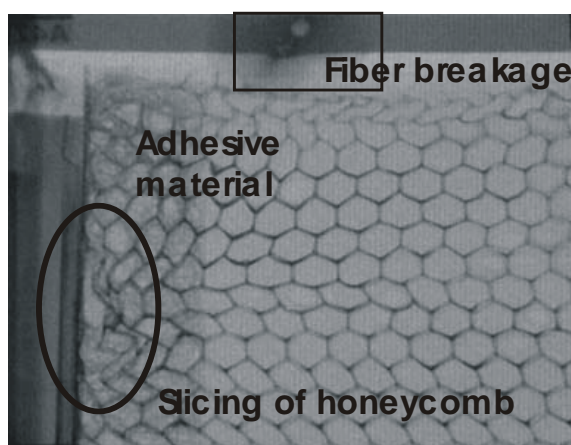
**(a)**

A fiber breakage (defect type 7 in Table 22-1) in the trailing edge is observable in Figure 22-10. In the same segment another type of defect was detected. Both NR and XR images show slicing of the honeycomb structure near the stiffener, however, the adhesive material can be detected only by NR. One of the most dangerous defects is when a de-bond (defect type 8) in the adhesive surface is present between the honeycomb structure and the aluminium spar. Such observations are illustrated in Figure 22-11. The double contour lines are because of the tilted position of the honeycomb elements. In this investigation one of the most important observations was the presence of cavities, holes and/or cracks in the sealant and at the border of the sections. The problems were caused by water penetrating into these places and freezing which caused damage to the surrounding structure due to the volume expansion of ice. Detection of these defects is very difficult because of the complex arrangement of the composite structure. A combination of ‘dry NR’, ‘wet NR’ and XR experiments made it possible to discover and visualize these defective areas. It was established that the most frequent locations of water penetration were at the border sections or at the honeycomb-adhesive sealant joining surfaces. These defects are visible in Figure 22-12.

**Figure 22-10: (a): Fiber Breakage and Slicing of Honeycomb and the Adhesive Material Revealed by NR; and (b): Fiber Breakage and Slicing of Honeycomb and the Adhesive Material Revealed by XR.**

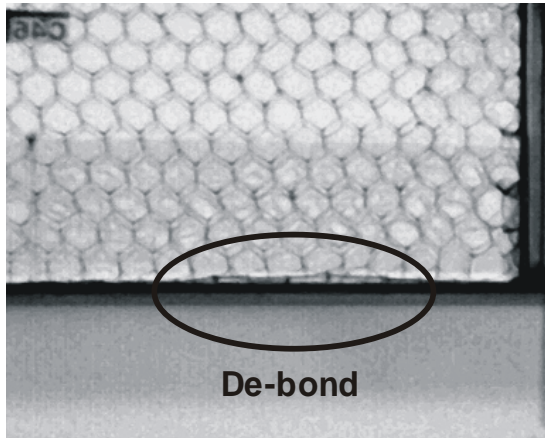
**Figure 22-11: De-Bond in the Adhesive Material Between the Honeycomb and the Aluminium.**

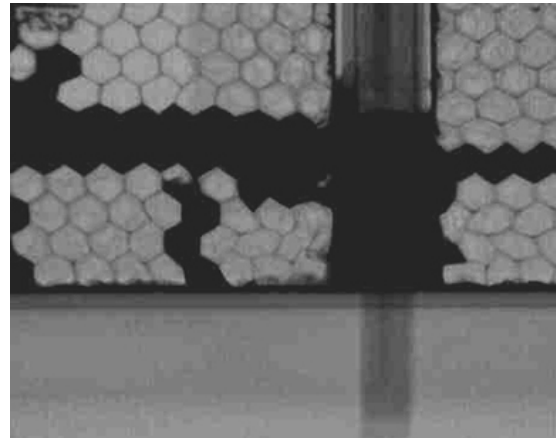
**Figure 22-12: Water Percolation in the Honeycomb Structures by NR.**

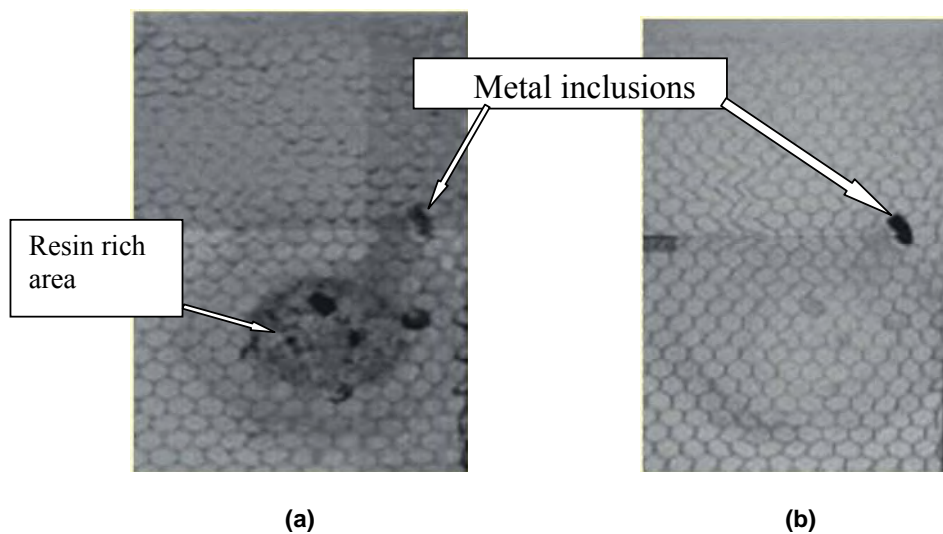
Damage caused by splinters may happen during flight missions (defect type 2 in Table 22-1). Our experience showed that such defects occurred during gunnery practice. Although these defects were usually repaired by the maintenance team, a small piece of splinter was not detected by them and thus it was not removed, as may be seen in Figure 22-13(a) NR and Figure 22-13(b) XR pictures. In the NR image the resin rich spots are seen to be as dark as the metal inclusion, while the XR image provides a dark contrast only for heavy elements with large X-ray attenuation.

**Figure 22-13: (a) NR Picture of the Repaired Area; and (b) XR Picture of the Repaired Area.**

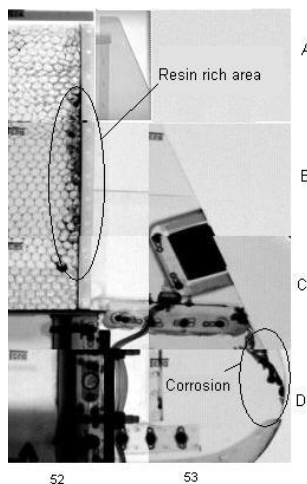
Corrosion may also cause problems, leading to possible lifetime reductions. Corrosion was detected in some of the investigated blades inside the rotor blade tail element, as shown in Figure 22-14. A resin-rich area is also shown at the bond surface of the honeycomb structure and the last stiffener. X-ray radiography is a complementary and useful tool in assessing the structural integrity of the metal parts of the blades. Figure 22-15 shows the heating element arrangements and their contacts on a blade with some corroded contacts.

**Figure 22-14: NR Picture of the Corrosion Product in the Tail of the Rotor Blade.**

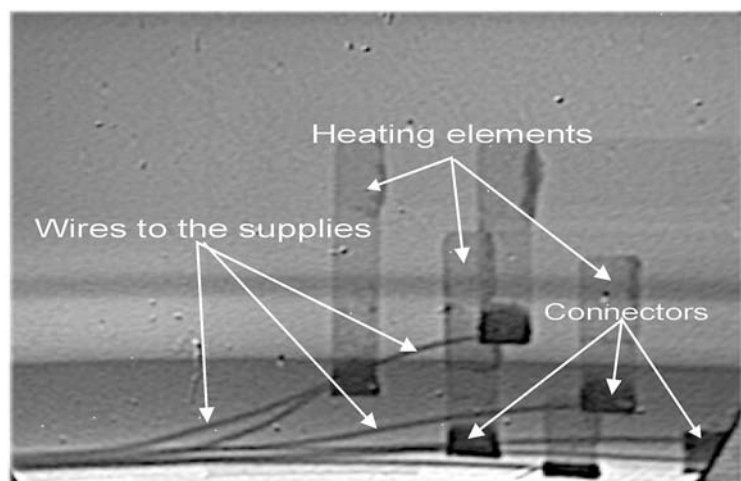
**Figure 22-15: Corroded Heating Elements of the Anti-Ice Heater System Revealed by X-Ray Radiography.**

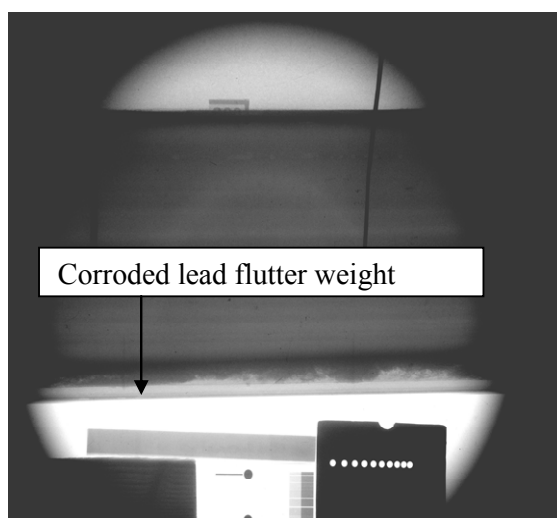
**Figure 22-19: Front Edge of the Ka-26 Helicopter Rotor Blade Revealed by NR with Corrosion Products on the Anti-Flutter Weight.**

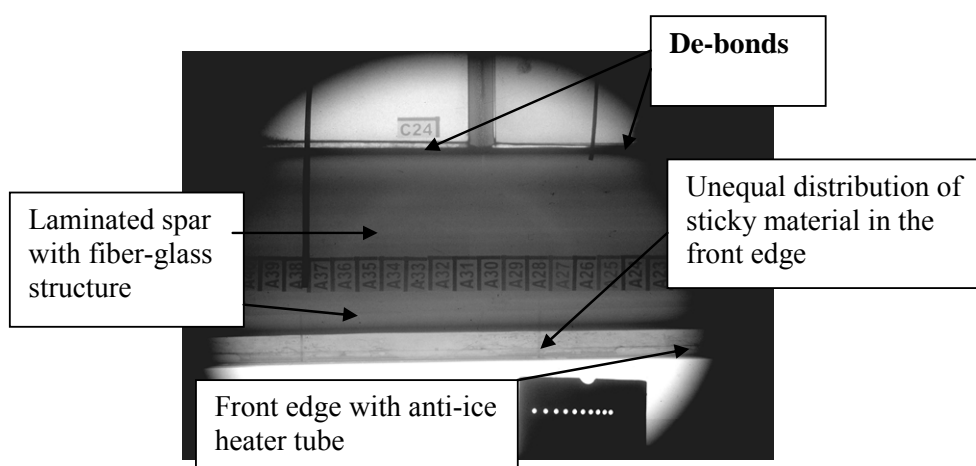
The NR picture of Figure 22-21 shows two areas of de-bond between the spar and the section. In addition one can see an unequal distribution of the sticky material on the lead anti-flutter weight at the front edge of the rotor blade.

**Figure 22-21: Spar in the Middle Part of the Ka-26 Helicopter Rotor Blade  
Revealed by NR with De-Bonds Between the Spar and the Sections.**
