## **Chapter 22 – INSPECTION OF HELICOPTER ROTOR BLADES BY NEUTRON- AND X-RAY RADIOGRAPHY**

**M. Balaskó and L. Horváth**  
MTA KFKI Atomic Energy Research Institute  
Budapest  
HUNGARY

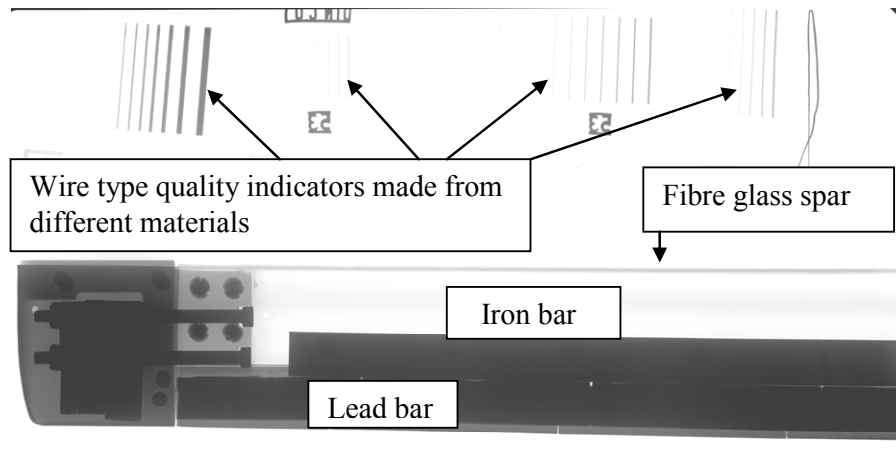
Figure 22-16: End Element of the Ka-26 Helicopter Rotor Blade by XR.

The structure of the plastic fiber-glass rotor blade is very different from the metal composite blade. It contains some metal parts, namely the root structure, anti-flutter weight (iron and lead bar), and some screws and adaptors. Some metal parts are visible in Figure 22-16 but the contrast of the iron and lead bars is not distinguishable by XR. A faint indication is given by the elements of the plastic fiber-glass spar. However many details of the plastic fiber-glass technology are observable in Figure 22-17. Clearly visible is the localization of the sticky material under the closing element of the blade and the border between the sections. It is easy to see that the neutron attenuation coefficient is higher for iron than it is for lead. The two complementary radiography pictures give complete information about the construction of the end element of the rotor blade. Under the blade some beam purity indicators, ASTM sensitivity indicators and step wedge indicators with holes are visible in Figure 22-17. The complementary characteristics of the XR and NR are documented in Figure 22-18 and Figure 22-19. The first one shows the perfect arrangement of the protecting aprons for the front edge. One may postulate that the form of the lead bar anti-flutter weight is intact under the protecting aprons. But this was not true because the materials of the lamination technology destroyed the lead bar. The surface of the lead bar appeared similar to the corrosion products as seen Figure 22-19. In order to study the quality of the fiber-glass bundles of the spar it was necessary to reduce the power of the X-ray generator as illustrated in Figure 22-20. In this figure one may see the perfect arrangement of the bundles. However the authors have no information about the bonding between the plastic fiber-glass spar and the cross-link polymer foam of the section.
